Manhole Inspection Summary

Manhole # S15QQ1001MH

Insp Date: **11/13/06 3:00 PM**

Location Address: **5022 YELLOWWOOD AVE**

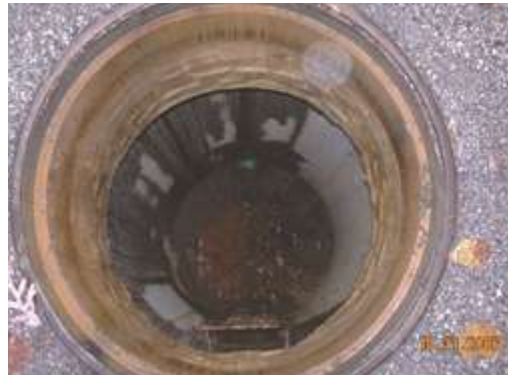
Top View

Channel debris.

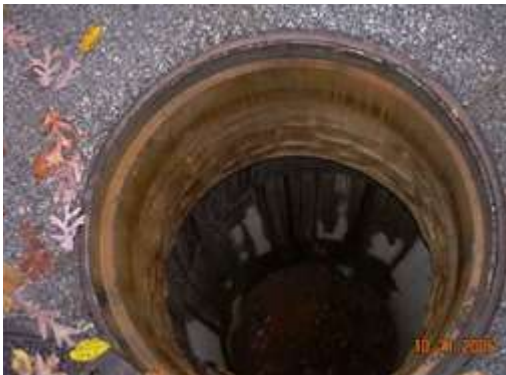
Defect

☒ **Leaks**

Infiltration: ☐ None ☒ **Joint** ☐ Cracks ☐ Mortar ☐ Roots ☒ **Wall**

Frame leaks. Frame offset. Adjustment infiltration.

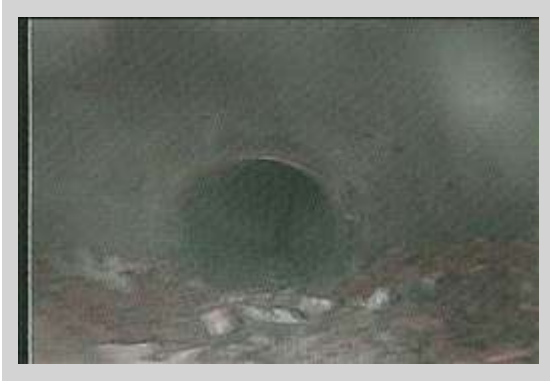
8 in. Circular Gravity Sewer
Pipe Out @ 12 O'Clock

Deposits: ☐ None ☐ Mud ☐ Sludge ☒ **Debris** ☐ Grease

Silt Depth: **0.5** (in.)

Deposits Extent: **Light**
